# BELZONA RAPID FLOOR REPAIR

ID: 1018

## PROBLEM

Hole in floor creating problem for fork lift drivers loading and unloading cardboard for box manufacture.

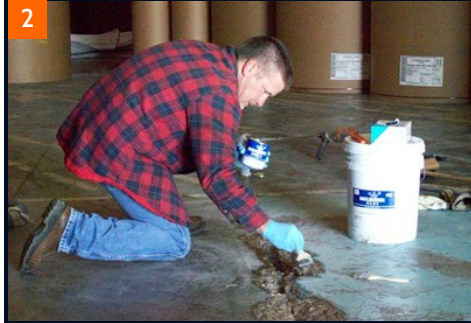
1. Removed concrete from hole
2. Belzona 4911 being applied
3. & 4. Finished application

The alternative was to saw cut concrete and pour new concrete. That would be more costly because of labor and down time in the area. It was possible to drive over the Belzona applied in morning that night.
