# HYDROPOWER DRAFT TUBE REBUILD

ID: 10181

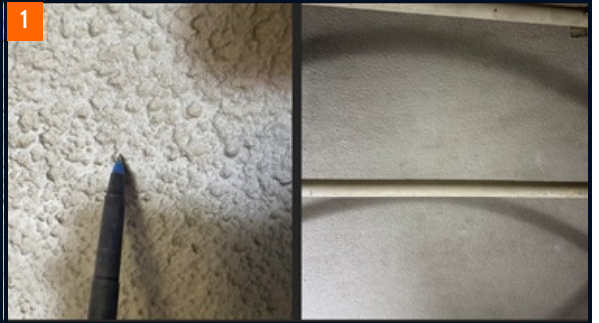
Systemic pitting across the draft tube wall indicated ongoing erosion and corrosion mechanisms that would continue to progress without intervention. A long-term protective solution was necessary to restore surface integrity and prevent further material loss. Belzona counts within the product range for a long-term solution.

1. Blasted surface
2. Belzona 1121 was used to rebuild pitting damage
3. Belzona 1321 Blue first coat
4. Belzona 1321 Grey second coat

200 square feet of carbon steel was grit blasted to a minimum of 3mils followed by rebuilding with Belzona 1121, then two coats of Belzona 1321. All work was performed in accordance with Belzona's instructions for use (IFU'S)
