# STRESS CRACK CORROSION REPAIRED ON INTERIOR OF REACTOR

ID: 10182

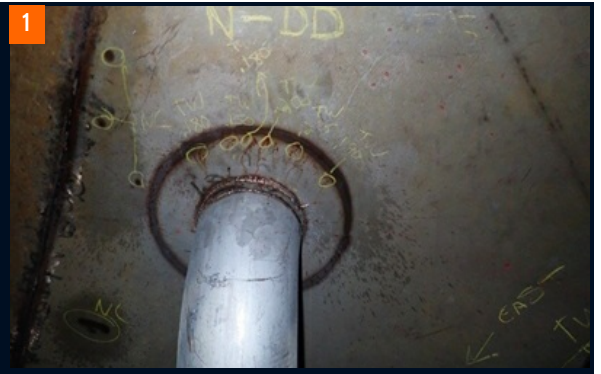
Customer was seeing stress, crack corrosion on the internal weld seems of their reactor, as well as pitting on the welds.

1. Stress, crack corrosion on welds around nozzle.
2. Area was blasted with aluminum oxide and Super Wrap II applied.
3. SuperWrap II was top coated with Belzona 5811 and 5111.
4. Secondary area completed with SuperWrap II and top coated with Belzona 5811 and 5111.

Each weld seem and area around the weld seem was blasted with aluminum oxide to provide a 3 to 4 mil profile on the stainless steel substrate.
