# SAFETY NONSKID FOR OFFICE ENTRY

ID: 10183

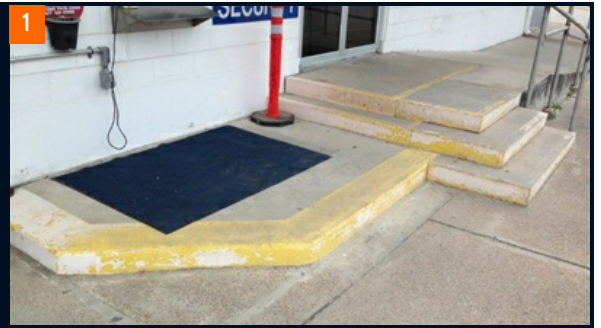
Non-skid safety markings leading into the customers engineering offices was wearing off after 14 years of service. The customer, a long time user of Belzona non-skid solutions was so impressed with the longevity of the 5231 that Belzona was their only choice to refresh the areas.

1. Worn Belzona 5231 areas from an application applied in January of 2000.
2. 14 year old non-skid application.
3. Areas refreshed with Belzona 5231 and 9221 Surefoot aggregate.
4. Refreshed and ready for another 14 years of service.

The surface was prepared by power washing to remove any loose coatings as well as dirt and debris. A diamond grinder was used to abrade the surface to provide an acceptable substrate. The first coat of 5231 was applied, then 9221 was broadcasted in for nonskid properties. A second coat of 5231 was applied within the overcoat window in accordance with the Belzona instructions for use.
