# BELZONA SEAL TO DRYER CAN SAVES MONEY

ID: 1019

Dryer can of paper machine.

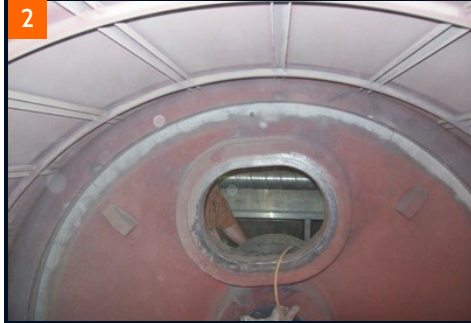
Gasket of dryer can failed and allowed steam to escape. Losing steam means losing money.

1. Start of job
2. Surface around joint grit blasted
3. Application of Belzona 1321
4. Application of Belzona 1311 to complete the repair

Application was carried out in accordance with a modified Belzona Know-How System Leaflet GSS-6. After grit blasting, a 2" band of Belzona® 1321 brush applied followed by Belzona® 1311 pressed firmly into the seam where the gasket had failed.
