# NAOH VESSEL LINED WITH BELZONA 1391S/T FOR LARGE PETROCHEMICAL SITE

ID: 10193

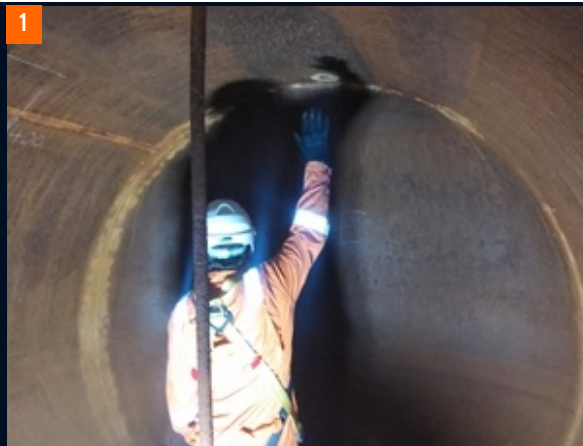
1. Taking measurements within the vessel on primary visit of the tank. The image provides a rough view of the diameter of the vessel, including some of the man way / nozzles requiring coatings too.
2. Another internal view of the vessel, highlighting the weld joints and rough idea of length of the vessel.
3. Following application with some hand applied remedial area already coated.
4. A further view following application highlighting further remedial areas that were going to be coated using 1391T.

The vessel was heated to maintain constant environmental conditions. The vessel was grit blasted to a profile of >75 micron average at a cleanliness of SA2.5. Spray application was required with stripe coating and hand applied remedial works following full lining. All nozzle and man ways were hand applied.
