# BELZONA KEEPS FLOATING HOSES AFLOAT

ID: 10195

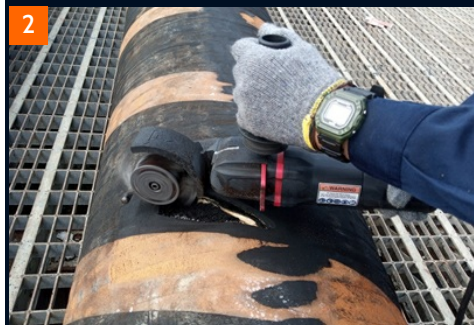
Twenty-four floating hose units in a refinery facility had experienced significant wear and tear on their rubber components in several locations, requiring immediate in-situ repair to maintain buoyancy and ensure proper operation. Without timely maintenance, the damaged rubber surfaces could deteriorate further, potentially disrupting operations and compromising the efficiency and safety of transfer activities within the refinery.

1. Damaged hose before repair using Belzona.
2. Surface preparation using an MBX Blister Blaster to roughen the rubber substrate.
3. Reconditioning of the damaged area using Belzona 2211 (MP Hi-Build Elastomer) and Belzona 9341 (Reinforcement Tape).
4. Final appearance after application of Belzona 2221 (MP Fluid Elastomer).
