# BELZONA REBUILD OF CORRODED RUDDER STOCK

ID: 102

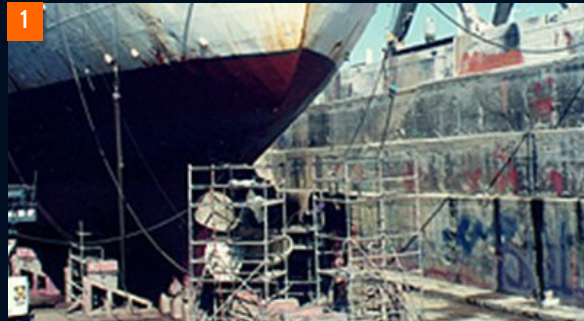
Severe erosion-corrosion caused by galvanic corrosion

Junction of stainless steel liner on rudder stock

1. Work underway on the vessel in dry-dock
2. The seal face of the liner was masked before grit blasting
3. Completed application

Application was carried out in accordance with Belzona System Leaflet SOS-1.

The excellent corrosion resistance of Belzona® 1111 and its insulation characteristics made it the ideal choice for long term protection in this area. It was a Bureau Veritas specification.
