# BELZONA REPAIRS RUBBER LINED BRINE TANK

ID: 1020

Rubber lined brine tank in over house of paper mill

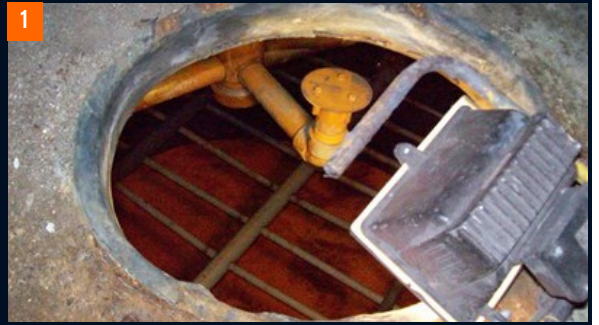
1. Opening to the tank
2. Exposed metal where repair to be made
3. Conditioner applied after grinding
4. Repair completed with Belzona 2111

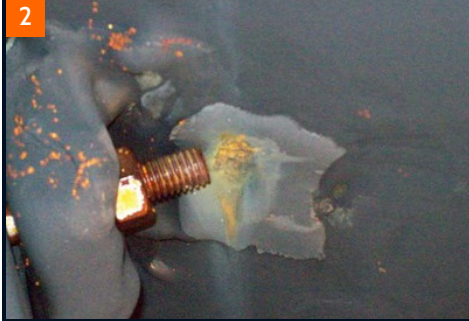
Rubber lining had been damaged locally. It was too costly to get specialist tank repair company to come and make repair.
