# BELZONA RESTORES 18 STRIPPED THREADS ON YACHT

ID: 10202

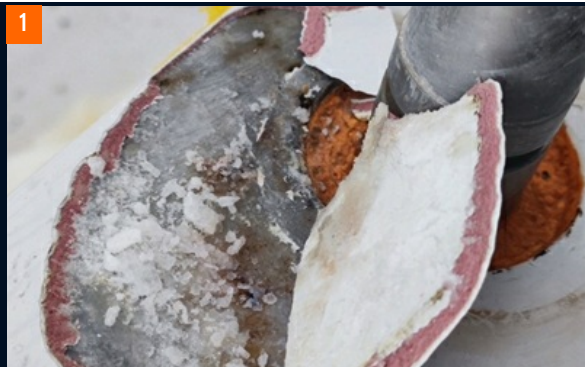
Handrails on the ship's hull were subject to galvanic corrosion between the bolts and the hull, resulting in delamination of the surrounding coating. An insulating solution was required to prevent further deterioration

The bolts securing the handrails on the ship's hull induced galvanic corrosion due to metal-to-metal contact between the bolts and the hull. This corrosion resulted in rust formation, which not only compromised the integrity of the metal but also caused visible staining and blistering of the hull coating. It was previously noted that the data on the system Leaflet ENC-2 was outdated and as a result new testing should be done, this project is a result of this testing from corporate.

1. Delamination of hull coating due to galvanic corrosion
2. Belzona 9411 being applied to threads
3. Once the bolt and substrate are wet out the bolt can be inserted into the hole.
4. Complete application showing restored thread

The restoration of stripped threads on the ship, was carried out in accordance with ENC-2. The handrail threads were cleaned using Belzona 9111 prior to the application of three thin coats of Belzona 9411 Release Agent. The bolt holes were machined to a diameter around 10% larger than the bolts which were used. As abrasive blasting was not possible, Dremels/rotary files and burrs were used to create a suitable profile. The holes were then vacuumed to remove contaminants, followed by cleaning with Belzona 9111. Once Belzona 1111/1121 was mixed, both the bolt holes and the bolt threads were wet-out before additional material was injected. The bolts were then inserted using a twisting motion. The Belzona was allowed to cure in accordance with its IFU.

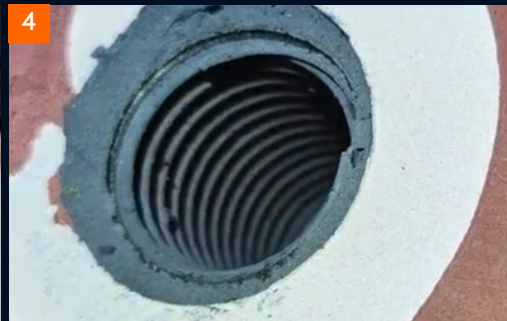
The client was very satisfied; in fact, the railings have been dismantled three times and the threads are still perfectly intact.
