# GYPSUM DUST BLOWER 7111

ID: 10205

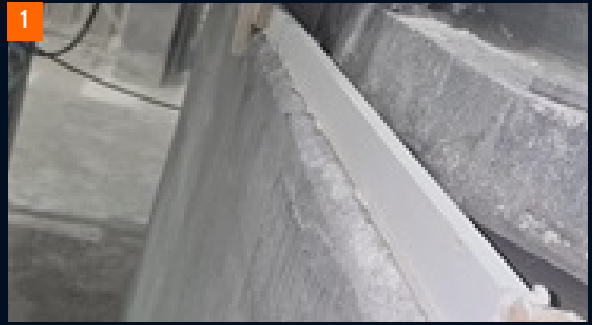
This blower was sitting on a concrete base. The main problem was that there was approximately 1 to 1 1/2 inch gap between the steel base of the blower and the concrete pad which cause vibration issues. The customer tried to fill in this gap with regular concrete but the severe vibration issues was causing the concrete to crack

1. A wooden containment was built around the area that we were planning to use 7111. This was regular with bought from Home Depot
2. This picture was taken straight after pouring was complete
3. Picture was taken the next day after 7111 was allowed to fully cure out and boards were removed
4. This picture shows the completed job only 48 hours after it was started
