# PROTECTION OF FLOOR AND WALLS IN A STORAGE ROOM FOR OIL AND LUBRICANTS WITH BELZONA COATINGS

ID: 10210

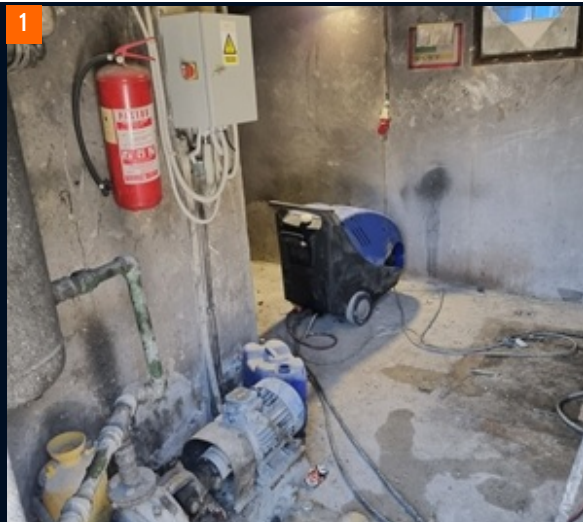
Walls and floor of an oil and lubricants storage room were uncoated, which caused permanent dirtiness and greasiness as well as unpleasant odor in the room. Such conditions in the room were unfavorable for employees and the first signs of deterioration of the concrete started to appear so a repair was required..

1. Situation before application.
2. Coating of walls with Belzona 5811.
3. Application finished on both walls and floor.
4. Situation after 2,5 years – coatings are still in good condition.

Application was carried out in accordance with Belzona Know-How System Leaflet FPA-3 (applied to both walls and floor). Surfaces were grinded using mechanical grinders and thoroughly washed with pressurized water and detergent in order to remove settled impurities. One coat of Belzona 5811 on the walls and two coats of Belzona 5231 on the floor were applied. During application of the first coat on the floor, Belzona 9221 (Surefoot) Aggregate was added in order to achieve anti-slip surface. It was later covered with second coat of Belzona 5231 to make cleaning of the room easier.
