# BELZONA STOPS ROOF LEAKS AND PROVIDES LONG-TERM PROTECTION

ID: 10211

Roof leakage was identified on a highly critical facility.

The scope of work was carried out on the roof of the Satellite Instrument Building, located in an oil and gas (O&G) processing plant. The roof is made of aluminum sheets coated with a thick layer of asphalt. The total surface area to be coated is 120 square meters.

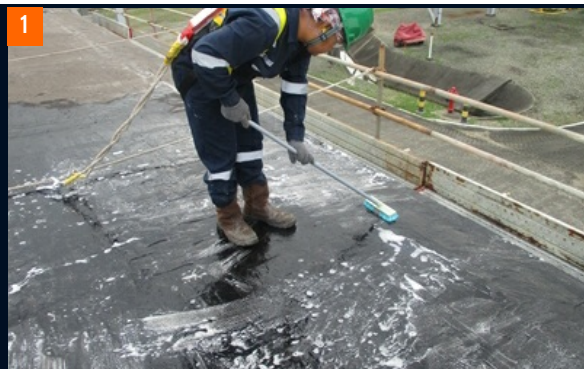
1. Surface cleaning was carried out to prevent contamination.
2. Belzona 3911 (PSC Surface Conditioner) was applied.
3. Application of Belzona 3111 (Flexible Membrane) in conjunction with Belzona 9311 (Reinforcement Sheet).
4. Finished appearance following the application of Belzona 3111 (Flexible Membrane).

1. The process began with preparation of the roof surface, which was cleaned using a detergent and then rinsed with running water until it was completely clean and free from contamination.
2. Once the surface was clean and dry, Belzona 3911 (PSC Surface Conditioner) was applied.
3. Subsequently, the Belzona 3111 (Flexible Membrane) system was installed, incorporating Belzona 9311 (Reinforcement Sheet) with a 3 cm overlap to ensure proper reinforcement.
