# BELZONA SOLUTIONS FOR REBUILDING AND COATING OF WAVE GENERATION TYRE RIMS

ID: 10213

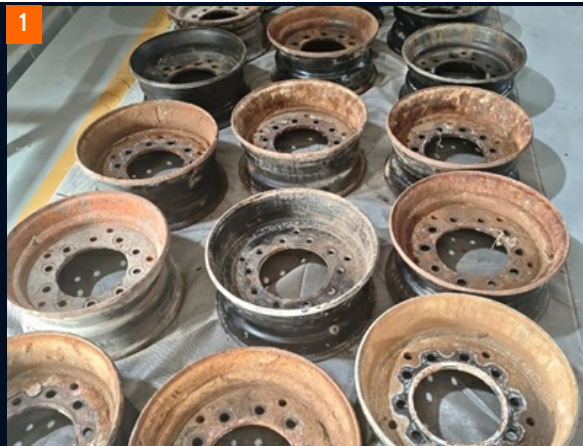
The track, manifold, and wave-generation system tyre rims have experienced corrosion, which may lead to future air leakage even within a short period of operation, resulting in a significant reduction in equipment efficiency. Furthermore, wear and deterioration around the rubber seals have compromised proper sealing, adversely affecting overall system performance and operational reliability.

1. The tyre rims of the wave-generation system have developed corrosion, which could result in air leakage within a short period of operation if not addressed.
2. The procedure began with grit blasting to obtain the specified surface profile, followed by thorough surface cleaning using Belzona 9111 (Cleaner Degreaser).
3. The pitted areas were subsequently restored using Belzona 1121 (Super XL-Metal) in accordance with the Belzona Instructions for Use (IFU). Upon completion of curing, the first coat of Belzona 5811 was applied.
4. Finally, a two-coat application of Belzona 5811 (Immersion Grade) was carried out in accordance with the IFU guidelines, ensuring long-term corrosion resistance and durable protection.
