# BELZONA SYSTEM TO HEADER BOX INTERNAL & EXTERNAL COATING

ID: 10224

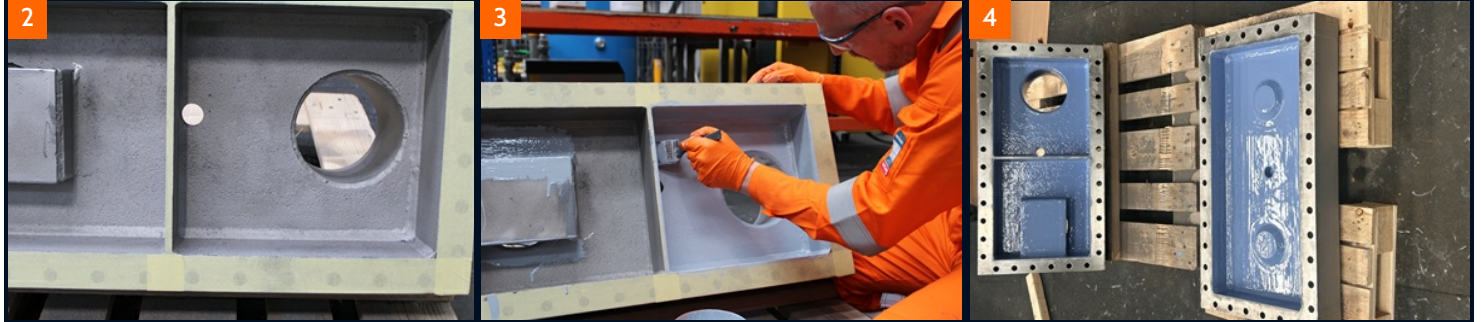
1. The header box delivered to Belzona UK's training and application facility
2. Areas are masked off and surface is grit blasted to minimum surface profile
3. First coat of Belzona 1341 is applied
4. Two coat solution of Belzona 1341 is applied, completing the repair solution

Grit blasting surfaces to minimum surface profile, two coats of Belzona 1341 was applied to the internal of the header box. To cover weld areas on the external of the box, weld areas were filleted with Belzona 1111, then two coats of Belzona 5811 were applied to the external of the boxes.
