# CHILLER TUBESHEET REPAIR

ID: 10229

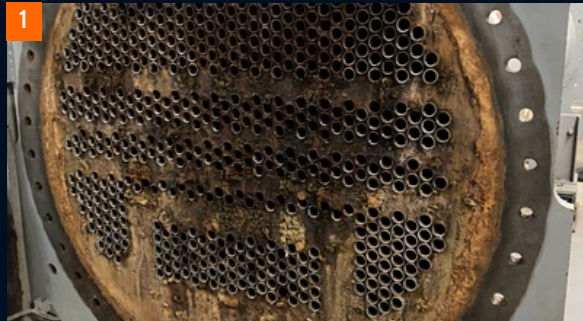
The carbon steel tubesheet of a chiller unit serving a commercial HVAC system had suffered significant deterioration due to a combination of erosion, general corrosion, and pitting. The constant flow of water across the tubesheet face had accelerated material loss, while galvanic interaction between the carbon steel tubesheet and copper alloy tubes further compounded the corrosion. Pitting had developed across the tubesheet surface, undermining the integrity of the tube-to-tubesheet joints and raising concerns about potential leaks and reduced heat transfer efficiency. Left unaddressed, continued degradation would have led to costly unplanned downtime and the risk of chiller failure during peak cooling demand. The customer required a reliable, in-situ repair solution that could restore the tubesheet surface, arrest further corrosion, and return the unit to service quickly without the need for hot work or tube bundle removal.

1. Heat exchanger experiencing erosion, general corrosion, and pitting.
2. Installation of corks in preparation for Belzona coating applications.
3. Application of Belzona 1311 and Belzona 1321.
4. Finished application.

Belzona 1311 was used to rebuild metal loss followed by two coats of Belzona 1321
