# PIPE REPAIR USING BELZONA 1161 AND SUPERWRAP II

ID: 10239

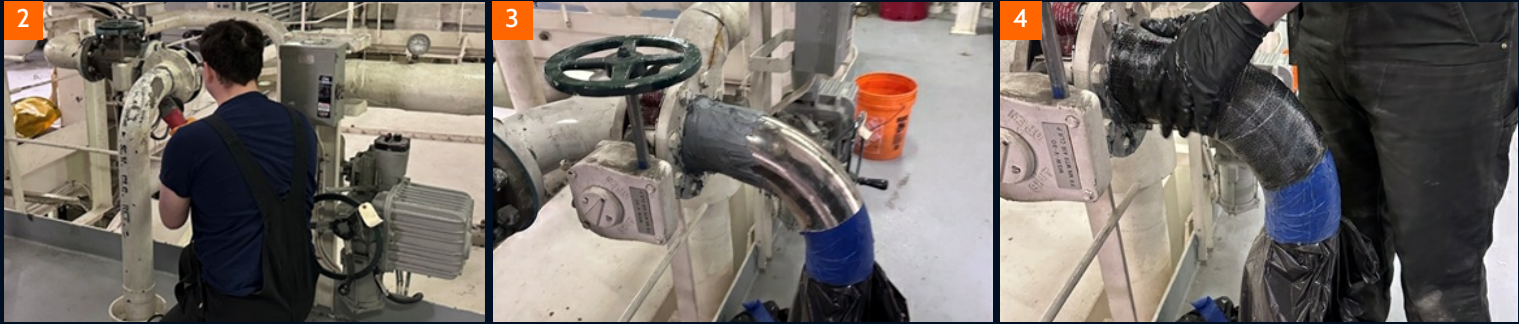
### PHOTOS

1. Temporary Repair Made at Sea
2. Surface Prep
3. Belzona 1161 Being Applied
4. SuperwrapII being applied

The temporary at-sea repair was removed and the damaged area of the 3-inch copper-nickel pipe was cleaned and prepared using mechanical methods including rotary tools and flap discs to remove corrosion products, expose bright base metal, and establish an adequate surface profile for adhesion. The prepared area was solvent cleaned to remove any residual contaminants. Belzona 1161 (Super UW-Metal) was mixed and applied to the damaged section of the pipe to fill the through-wall defect, rebuild lost wall thickness, and create a smooth, uniform surface geometry suitable for overwrapping. Once the Belzona 1161 filler had been shaped and the substrate contour restored, the Belzona 1984 (SuperWrap II) composite system was applied over the repair area. Belzona 9381 reinforcement sheet was saturated with the Belzona 1984 resin and wrapped around the pipe in accordance with Belzona's Instructions for Use (IFU's), with Belzona 9382 release film applied as the final outer layer. The total application time was approximately two hours. The completed repair was allowed to cure for four days before the system was returned to service.
