# BELZONA PREVENTS COSTLY LEAKAGE

ID: 1024

Ball Mill used to grind limestone for cement production.

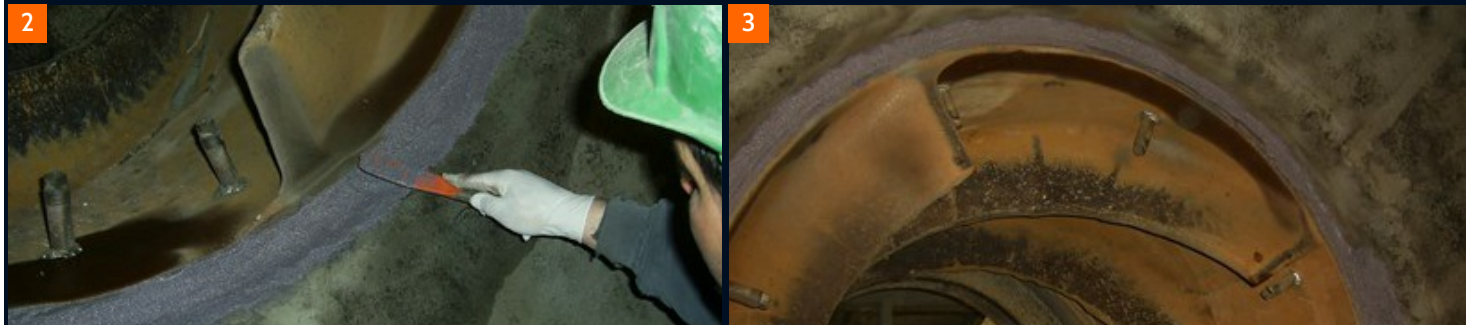
The ingress of limestone particles into the 10-20mm gap between the tubular screw conveyor and its housing leads to wear and leakage of milling media outside the mill.

1. View of the gap between the tabular screw conveyor and the housing
2. Belzona 1812 being applied
3. Completed application

Application was carried out in accordance with modified versions of Belzona Know How Leaflet GSS-9 and VPF-2.

The Belzona was chosen in order to prolong the life of tubular screw conveyor. The customer had used different epoxy-based products to solve the problem but with limited success. Welding was not considered due to high cost and stress buildup. The Belzona solution proved to be much easier and faster to apply saving the plant more than 5000 euros in replacement and maintenance costs.
