# QUICK TURN AROUND FOR T- PIPE USING BELZONA 7311 AT PETROCHEMICAL PLANT

ID: 10240

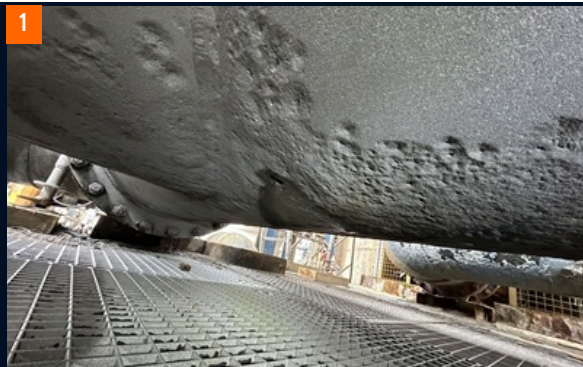
Corrosion had caused perforation on a cooling water pipe in a petrochemical site that produces ammonium nitrate fertilizers had caused the pipe to leak severely. This pipe was operating in the nitric acid area and therefore the corrosion was very intense. The Client needed a quick and repair method that could be carried out within a very short shutdown period but also provided a long-term solution.

1. Damage pipe
2. Belzona 1212 applied to seal a live leak and rebuild the pitted area
3. Curved plate bonded using Belzona 7311
4. Image of T- bend pipe

The surface was prepared by using sandblasting and the perforation was sealed using Belzona 9611. The damaged areas next to the perforation were then repaired using Belzona 1212, then the curved plate was bonded using 24 unites of Belzona 7311 with straps for tightening. Finally, a layer of Belzona 5811 was applied to provide protection from future damage as the corrosion was very intense.
