# CORRODED BULKHEAD REINFORCED WITH BELZONA

ID: 10245

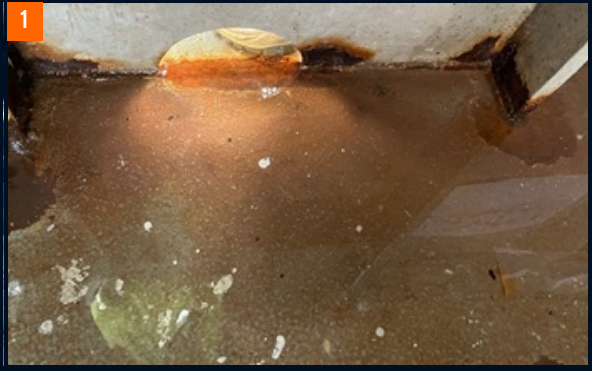
1. Continually wet conditions surrounding the mainmast made conventional solutions impractical
2. Localised corrosion evident in several locations at the base of the bulkhead
3. Each location was prepared with a flap disc and MBX to an average of 60 microns in line with SSPC-SP11.
4. Steel doubler plates bonded in place and ready for painting

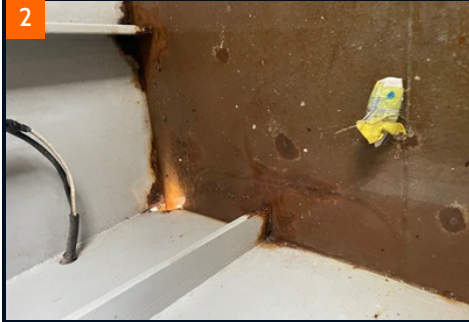
Localised corrosion on the bulkhead surrounding the mainmast was noticed during a routine inspection. If ignored, this issue would have led to pitting and through-wall corrosion, compromising the structural integrity of the bulkhead and leading to a lengthy removal and replacement. As the ship was not scheduled for a largescale maintenance overhaul, the client needed a fast, non-invasive solution.
