# BELZONA REPAIRS CASING OF CEMENT BALL MILL

ID: 1025

Ball Mill used to grind limestone for cement production.

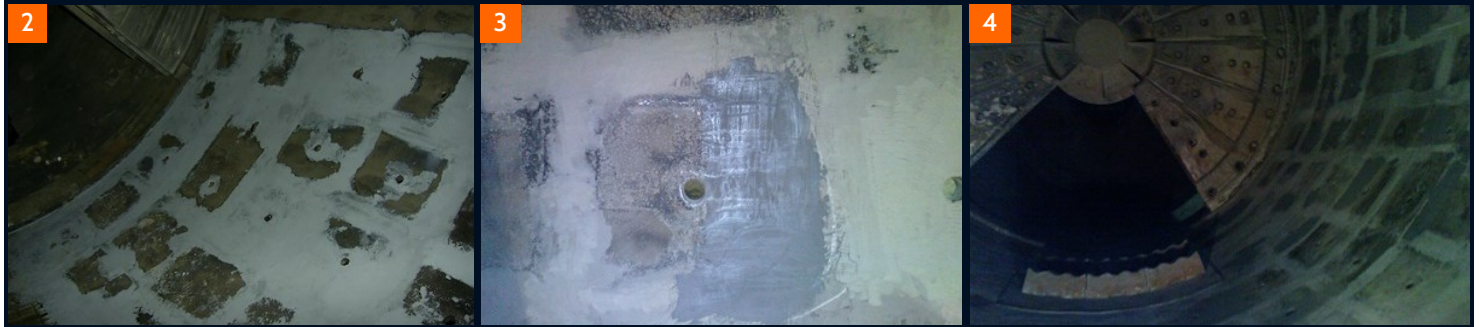
Wear on the shell when operating with missing protective tiles.

1. View of the damage to the shell after dismantling the tiles
2. Application of Belzona 4111 after blasting of the surface
3. Smoothing of the area with Belzona 1121
4. Application of Belzona completed and the bolting of the new wear plates over the repair has started

Both Belzona products were used to restore the profile of the shell in order to fulfill the strict requirements of the tile manufacturer before the installation of new tiles.
