# BELZONA SOLUTION FOR SEAWATER BUTTERFLY VALVES

ID: 10250

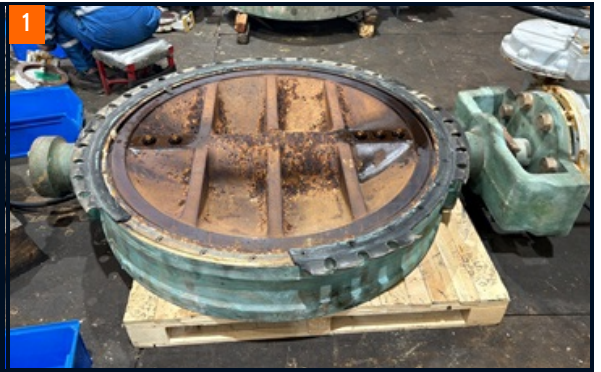
An onshore client experienced severe erosion-corrosion in several butterfly valves, compromising their integrity and operational performance. A detailed technical assessment was conducted, followed by refurbishment and the application of corrosion protection systems to restore reliability and ensure optimal functionality.

1. Critical erosion-corrosion damage in butterfly valves.
2. Abrasive blasting was carried out to SA 2.5, achieving a 75-micron surface profile.
3. Belzona 1311 (Ceramic R-Metal) was used to rebuild the damaged areas.
4. Two coats of Belzona 1321 (Ceramic S-Metal) were applied to provide enhanced protection.
