# CONCRETE PUMP PLINTHS REPAIRED WITH BELZONA

ID: 10251

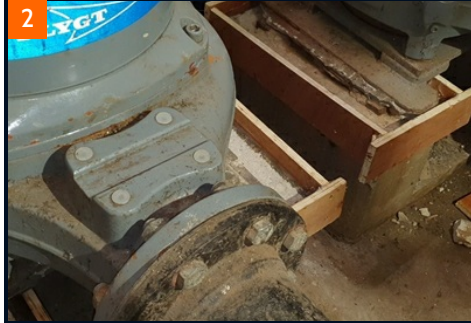
Customer was facing issues with damaged concrete pump plinths at a pumping station which had previously been repaired with cement/concrete material, which had failed after a period of time due to vibrations from the pumps. The customer was looking for a more permanent long term solution for the application.

1. Concrete plinths had been worn away due to vibration from pumps
2. The plinths required a long term durable solution that can withstand the effects of constant vibration
3. The shuttering is applied around concrete plinths and Belzona 7111 is poured into the recess
4. Belzona 7111 is cured and the plinths now have a durable base for the pumps

After carrying out a site survey, Belzona 7111 Chocking compound was recommended for the repair of the five plinths. All loose concrete was removed back to solid concrete. Shuttering was cut to size, coated with a release agent and assembled around the plinths. Belzona 7111 was mixed and poured into the dammed voids and allowed to cure. Once cured, shuttering was removed.
