# CAN FILLER SUPPORT FRAME PROTECTED WITH BELZONA 4341

ID: 10252

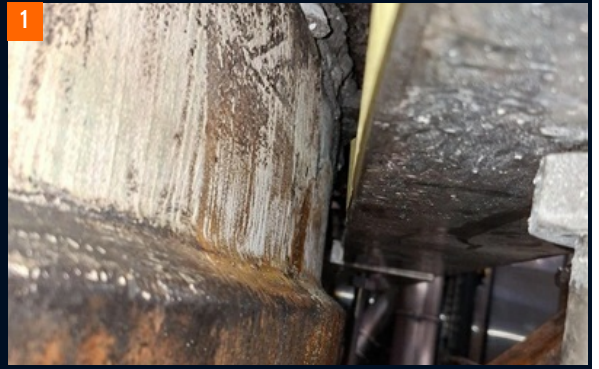
Over time, the support structure has been coated with various paint systems. Unfortunately, these have not performed as intended and were breaking down at an accelerated rate, leaving the underlying steelwork insufficiently protected.

1. Previous coatings had proven inefficient and underlying steelwork was insufficiently protected
2. Support structures required a long term solution against chemical attack
3. Belzona 4341 was applied as a long-term solution for protection against chemical attack
4. Completed application of Belzona 4341 enhances durability and extends operational life of support structure

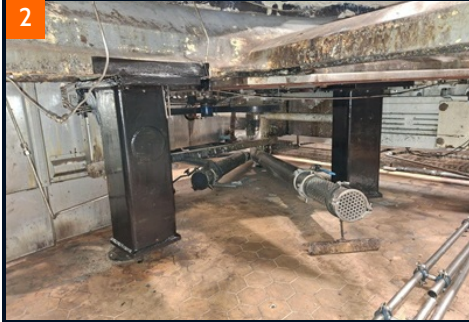
Customer has a filler line that is regularly subjected to chemical cleaning processes. The upper section of the line is constructed from stainless steel and operates to a high standard. However, the support frame is manufactured from cast material and was installed prior to the stainless steel upgrade and is now exhibiting signs of corrosion due to repeated chemical attack.
