# BELZONA REPAIRS A CORRODED FLANGE AT A GAS YARD

ID: 10255

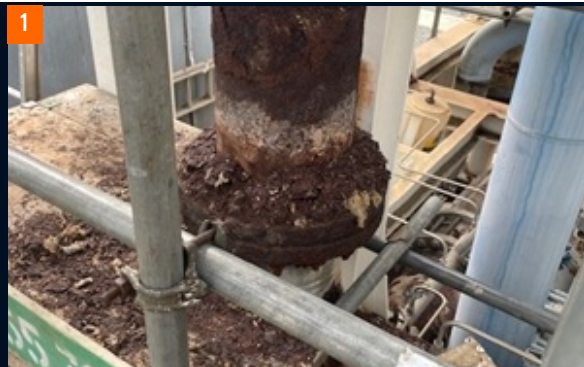
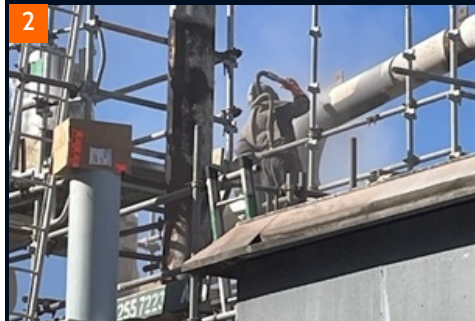
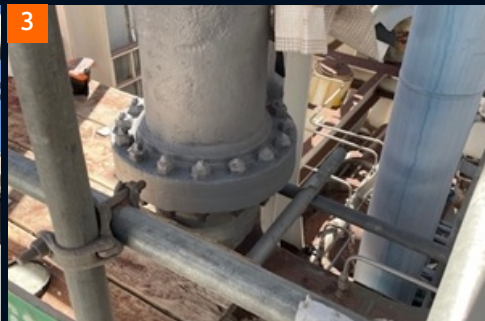
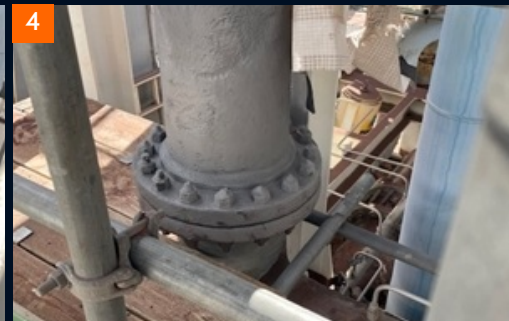
## PHOTOS

During routine maintenance, a section of pipe (originally under insulation) was found to be severely corroded, with the flange particularly affected. The client determined that the best course of action was to seal the pitting and the flange boundary using Belzona as a temporary measure until the next shutdown.

1. The flange was severely corroded, requiring the bolts to be cut out for disassembly.
2. Grit blasting of the pipework was carried out and took most of the morning.
3. Once blasted, the flange was found to be in satisfactory condition, and the client decided to carry out a temporary repair using Belzona 1111 (Super Metal) until the next major maintenance shutdown.
4. Condition of the flange boundary after sealing with Belzona 1111 (Super Metal).

After blast cleaning, the asset is inspected and the metal thickness is assessed. Belzona 1111 (Super Metal) is then used to restore the original geometry of the flange and seal the boundary. This ensures that the asset can be repainted and returned to service without the need for replacement.
