# BELZONA REBUILDS LINER SEAL GROOVES

ID: 1026

Main diesel engine cylinder liner 700 mm diameter

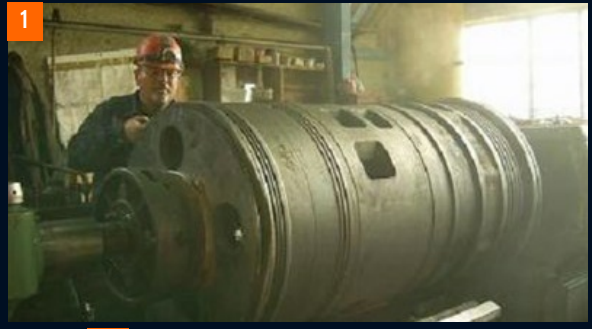
1. The liner on the lathe
2. Severe pitting corrosion clearly evident after grinding and blasting
3. Application of Belzona 1111 on the seal grooves in progress
4. Seal grooves machined down on the lathe to restore original profile

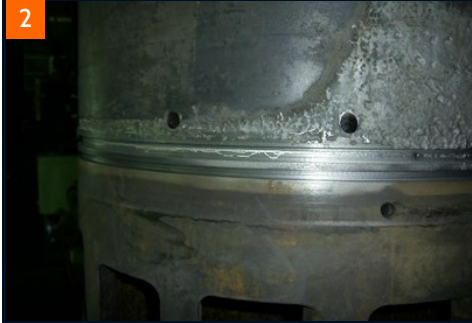
Severe pitting corrosion on the liner body and damaged seal grooves
