# MUD PUMP CASING REPAIR AND PROTECTIVE COATING APPLICATION

ID: 10263

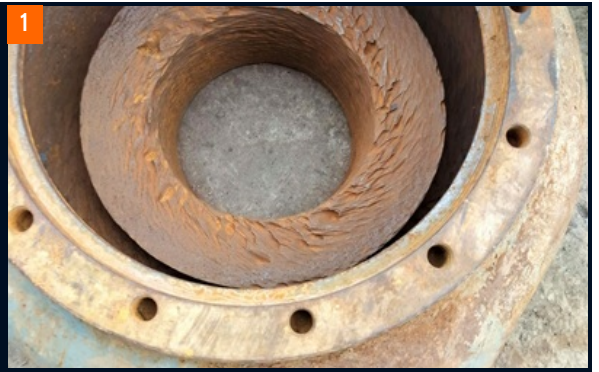
Our esteemed customer required restoration of metal loss to recover optimal flow rate and to protect the pump casing from ongoing damage caused by extreme wear during the extraction of oil contaminated with soil, grit, rocks, and other abrasive materials. Due to these severe operating conditions and excessive erosion, the pump casing was typically damaged within three months. Therefore, a cost-effective solution was required to improve service life and enhance equipment longevity.

The mud pump is used to extract oil mixed with mud, grit, and rocks, creating a highly abrasive and corrosive operating environment. These materials continuously erode and mechanically damage the pump components during operation. Belzona 1311 (Ceramic R-Metal) was applied to rebuild and repair the damaged areas. The surface was then overcoated with Belzona 1321 (Ceramic S-Metal). These materials were selected for their excellent resistance to corrosion and erosion, restoring the casing profile and providing long-term protection against further damage.

1. Severe erosive wear of the pump casing due to the presence of grit and rock particles in the mud and oil extracted from underground formations.
2. Surface preparation carried out using hand-held tools.
3. The damaged portion was rebuilt using Belzona 1311 (Ceramic R-Metal).
4. The application was completed using Belzona 1321 (Ceramic S-Metal).
