# BELZONA RESEATS NEW RUDDER BEARING BUSH

ID: 1027

Ships rudder bearing

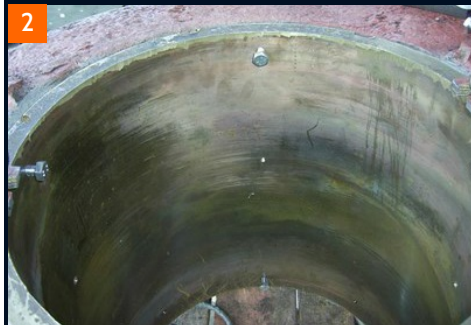
Severe corrosion and impact wear of the bush housing resulted in annular gap between the housing and the bearing bush in excess of 8 mm.

1. Severe corrosion on the housing clearly evident after blasting
2. New bearing bush with drilled injection ports and jacking bolts for alignment
3. Sealing the bottom of the bush with Belzona 1221
4. Injection of Belzona 1321 completed
