# TUBE SHEET HEAT EXCHANGER REBUILDING AND PROTECTIVE COATING

ID: 10273

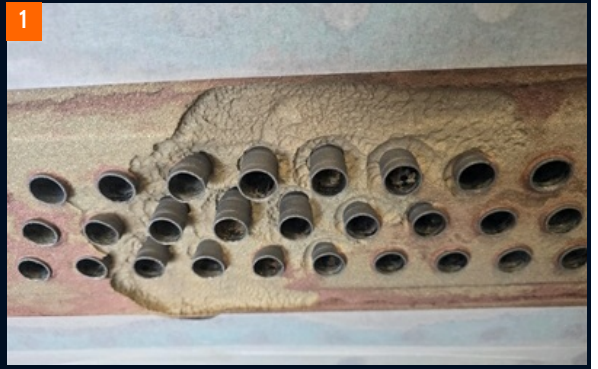
The customer manufactures and supplies heat exchanger units to end users under warranty. Units in service were experiencing premature failures caused by erosion and corrosion due to the high salt content of the water media, resulting in pitting, wall loss, and leaks at the tube sheet and water box. These failures were occurring within the warranty period, creating significant financial liability and reputational risk for the manufacturer.

1. Metal loss observed on the heat exchanger tube sheet.
2. The tube sheet was rebuilt using Belzona 1111 (Super Metal) and coated with Belzona 1321 (Ceramic S-Metal).
3. The covers were rebuilt using Belzona 1111 (Super Metal) and coated with Belzona 1321 (Ceramic S-Metal).

1. The unit was cleaned and the surface prepared by abrasive blasting to achieve SSPC-SP10 / ISO 8501-1 Sa 2.5 cleanliness, removing all corrosion products and achieving the required anchor profile.
2. The pitted areas, wall loss zones, and tube sheet face were rebuilt to the original profile using Belzona 1111 (Super Metal), applied by Belzona spatula.
3. Belzona 1111 (Super Metal) was allowed to cure fully before overcoating.
4. Two full coats of Belzona 1321 (Ceramic S-Metal) were applied by brush and roller to the tube sheet face, water box interior and cover.
5. Holiday testing was carried out on the completed lining prior to returning the unit to service.
