# CONDENSER TUBE SHEET REPAIR AND PROTECTION IN A POWER PLANT

ID: 10274

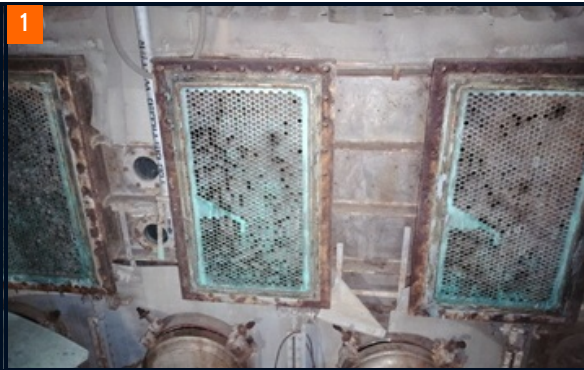
A major power plant was experiencing severe corrosion damage to condenser tube sheets, resulting in deterioration of the tube sheets and associated tubes. The mechanical contractor initially recommended complete replacement of the tube sheets and related tubing. However, this raised significant concerns for the plant authorities due to the high replacement cost, extended shutdown duration, and potential impact on power generation operations.

1. Initial condition of the heat exchanger tube sheets.
2. Cork plugs installed prior to abrasive blasting to protect the tubes during surface preparation.
3. Tube sheets after abrasive blasting to SSPC-SP10 / ISO 8501-1 Sa 2.5 cleanliness standards.
4. Tube sheets rebuilt using Belzona 1111 (Super Metal) and coated with Belzona 1321 (Ceramic S-Metal).
