# INTERNAL COATING OF EJECTOR AFTER CONDENSER VESSEL

ID: 10276

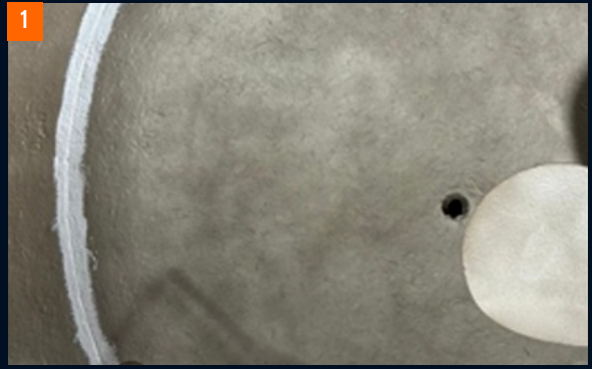
1. Rebuilding vessel weld seems with Belzona 1511
2. Rebuilding weld seems with Belzona 1511
3. External view of vessel
4. Internal coating of vessel with Belzona 1593

Due to signs of corrosion and pitting found on the internal surface of this high risk vessel, the client approached the distributor for advice on the protection of the vessel from further erosion/corrosion. Upon information received from the client, the following Belzona products were recommended. For rebuilding, Belzona 1511 (HT paste grade) and for corrosion/erosion Belzona protection Belzona 1593 was recommended. The application team completed the work in 4 days following the IFU specification. This directly contributed to extending the vessel's life expectancy.
