# BELZONA 7311 RESTORES THICKNESS TO STORAGE TANK

ID: 10277

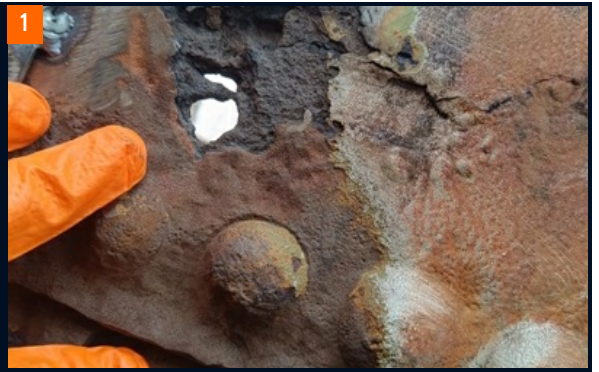
Severe corrosion on a brine storage tank was causing critical loss to the thickness. These tanks operate at a temperature range of 5°C to 40°C, and the customer required a cold bonding solution restore the holes and thickness in the tank. As you can see from the photographs the damage was quite serious in certain areas of the tank.

1. Damage to the tank
2. Further larger damage to the tank
3. Belzona 1161 applied to thinner wall damaged areas
4. Belzona 7311 used to bond thicker plates
