# TANK BASE SEALING ON HOT AND COLD SUMP VESSELS

ID: 10278

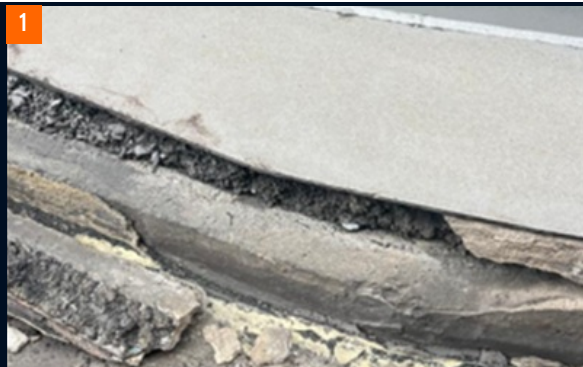
Worn and corroded bases on two storage tank vessels (Hot and Cold sumps) demanded attention to prevent structural failure or leaks. The Distributor was contacted by the Smelter Mine to inspect the vessels and provide a suitable and cost effective solution. The application approach using this two product system provides exceptional preventative and structural benefits.

1. On inspection
2. Rebuilding the concrete with Belzona 4111 Magma-Quartz
3. After applying Belzona 3111 Flexible Membrane
4. After applying Belzona 3111 Flexible Membrane to vessel base
