# BELZONA REPAIRED WATER BOX FLANGE

ID: 1028

Condenser water box.

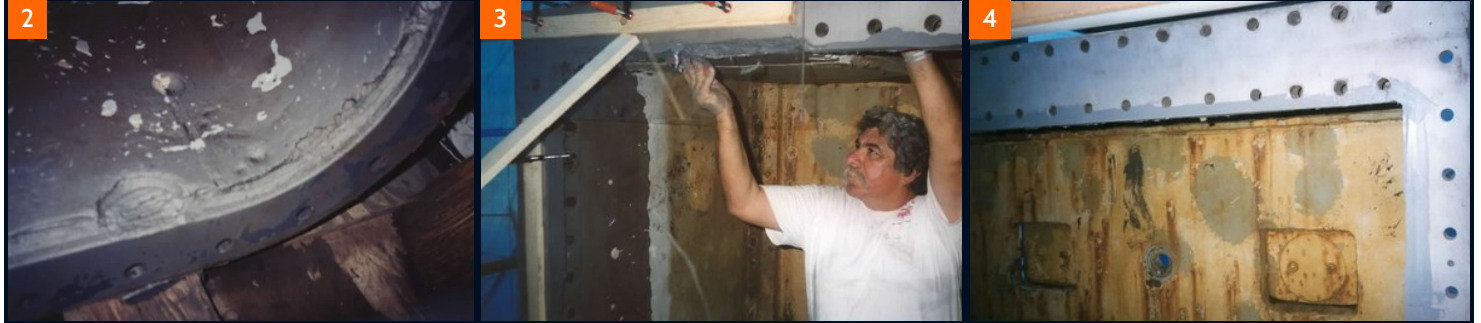
Corrosion on flange faces of the water box caused severe vacuum leaks, which triggered unit to shut down at the Power Plant.

1. Condenser water box.
2. Water box removed showing of corrosion damage.
3. Repairs being made with plexiglass former.
4. Newly formed flange face.

The application was carried out in accordance with Belzona Know-How System Leaflet GSS-8.

Belzona 1111 (Super Metal).
