# BELZONA LEAK SEALING AND REINFORCEMENT WORK ON CONDENSER WATERBOX OUTLET

ID: 10282

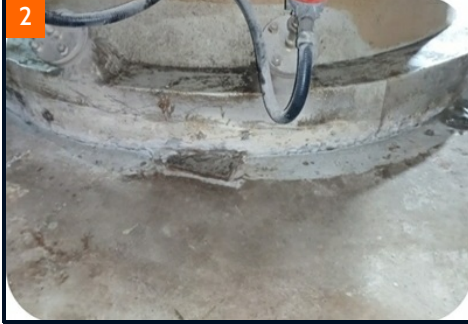
The lower section of the condenser waterbox outlet suffered severe corrosion and wall penetration due to continuous exposure to seawater and other corrosive media. The deterioration caused leakage, resulting in reduced structural integrity, operational inefficiencies, damage to surrounding equipment, and potential environmental contamination.

1. Damaged on the lower section of condenser waterbox
2. Surface preparation before rebuilding the damaged concrete
3. Belzona 4111 (Magma-Quartz) rebuilt the damaged concrete at the lower section of the condenser waterbox outlet
4. Belzona 5811 (Immersion Grade) coated on the rebuilt concrete at the lower section of the condenser waterbox outlet
