# PROTECTING PAPERMILL VOLUTE PUMP CASINGS FROM SEVERE ABRASION WITH BELZONA

ID: 10283

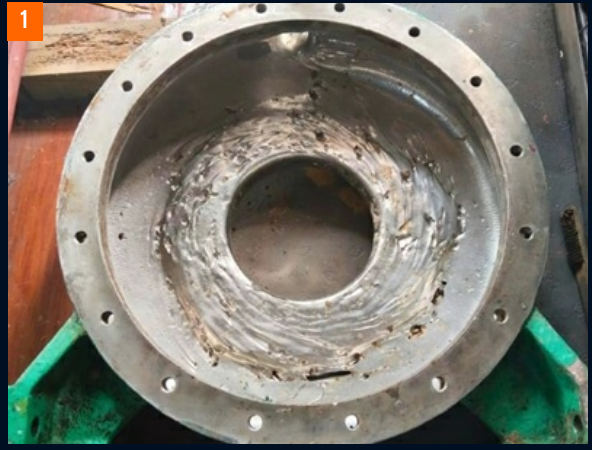
The volute pump casing used in the papermill operation suffered severe abrasive wear and leakage due to continuous exposure to abrasive slurry during operation. Progressive erosion of the internal surfaces resulted in material loss, reduced pump efficiency, and increased risk of equipment failure. The worsening condition eventually required shutdown of operations for immediate repair and restoration to prevent further operational losses and unplanned downtime.

1. Severe abrasive wear and leakage
2. Belzona 1161 (Super UW-Metal) rebuild completed prior to installation of Belzona 9811 Alumina Tiles
3. Installation of Belzona 9811 Alumina Tiles completed
4. Completed installation and grouting of Belzona 9811 Alumina Tiles

The damaged volute pump casing was initially cleaned and mechanically prepared to remove contaminants, corrosion products, and deteriorated material. Surface preparation was carried out using grinding and abrasive blasting to achieve a clean and roughened profile suitable for bonding. Belzona 1161 (Super UW-Metal) was then applied to rebuild and restore the worn metal surfaces. After rebuilding, Belzona 1812 (Ceramic Carbide FP) was used as the adhesive and grout material for the installation of Belzona 9811 Alumina Tiles. The alumina tiles were carefully installed with no gaps to ensure maximum abrasion resistance and proper alignment along the internal contours of the volute pump casing. Final inspection was conducted to verify complete coverage and proper tile bonding prior to returning the equipment to service.
