# BELZONA PROTECTS 165 MW HYDROELECTRIC GENERATING UNIT FROM EROSION-CORROSION AND CAVITATION DAMAGE

ID: 10285

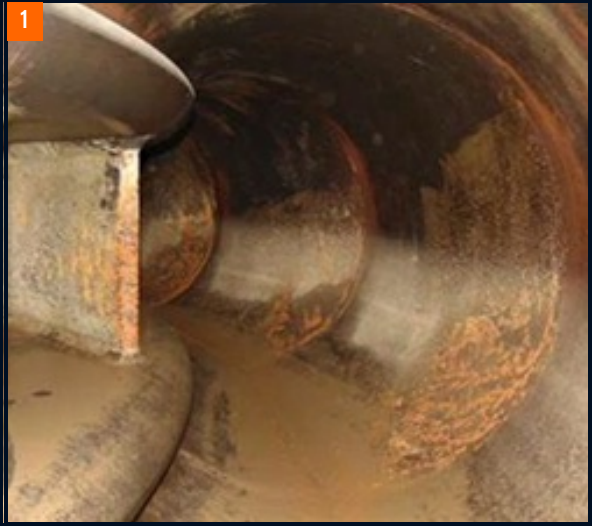
Continuous exposure to high-velocity water flow and entrained particles caused erosion-corrosion and cavitation damage on critical waterways components of Unit 1 at a hydroelectric power plant. The deterioration was evident on the spiral casing, stay vanes, guide vanes, turbine runner, draft tube cone, and draft tube wall, threatening hydraulic efficiency, equipment reliability, and long-term operational performance.

1. Erosion-corrosion and cavitation damage identified on the turbine waterways prior to repair.
2. Mechanical surface preparation completed to remove deterioration and prepare the substrate for Belzona application.
3. Ongoing application of Belzona coating systems to protect critical turbine waterways against erosion-corrosion and cavitation.
4. Completed Belzona coating system providing long-term protection for Unit 1 hydroelectric turbine waterways.
