# NITRIC ACID STORAGE TANK STAIR SUPPORT REPAIR

ID: 10286

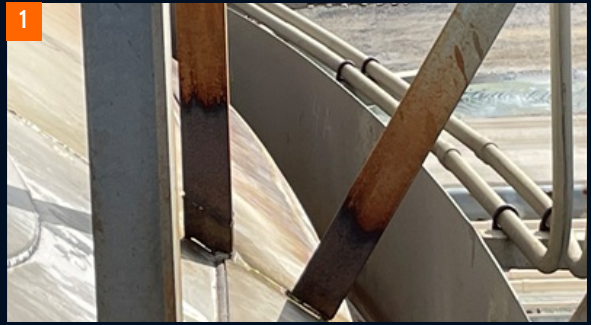
During inspection of the N4 Nitric Acid Storage Tank, Customer discovered that several welds attaching the roof access stair support brackets to the tank roof had separated. These brackets are critical for supporting the stairway used to access the top of the tank for inspection and maintenance activities.

1. Failed welds on the stair support brackets had separated from the tank roof, creating a structural concern and requiring an engineered repair solution without the use of hot work.
2. Two layers of Belzona 9341 reinforcement fabric were embedded into Belzona 7311 over the bonded plates, creating a high-strength composite system that restored the structural connection.
3. Two layers of Belzona 9341 reinforcement fabric were embedded into Belzona 7311 over the bonded plates, creating a high-strength composite system that restored the structural connection.
4. The completed repair was finished with a protective coat of Belzona 5721, providing long-term UV and weather resistance while restoring the stair support system without hot work.

The repair area was prepped by removing the existing coating and corrosion to create a solid surface for bonding. Belzona 7311 was then used to rebuild the failed weld areas and bond custom-fabricated steel plates between the tank roof and stair supports. Once the plates were secured, two layers of Belzona 9341 reinforcement fabric were installed and saturated with Belzona 7311 to create a high-strength composite repair. After curing, the repair was coated with Belzona 5721 to protect against UV exposure and weathering.
