# SURFACE TOLERANT DECK REPAIR WITH BELZONA

ID: 10288

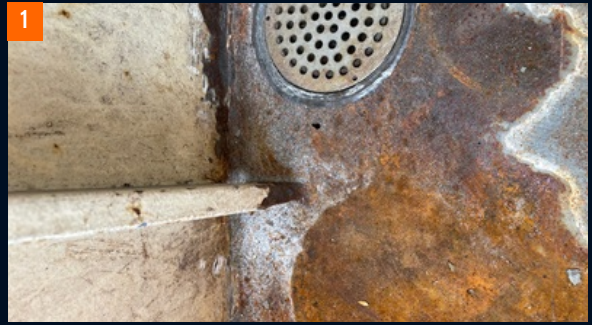
Due to misalignment of the scupper drain, salt water had ponded in the corner of a storage locker and caused localized pitting and penetrations in the deck. This was causing water to leak through the deck and into the ship. Left unchecked this leak would have caused thousands of dollars of damage and allowed water through to the lower decks which could have affected normal operations and was an unacceptable hazard for the client.

1. The scupper rim had been installed proud of the surrounding deck allowing water to pond around it and corrode through the deck
2. MBX preparation ensured that there was minimal noise and dust produced during surface preparation
3. Belzona 1161 (Super UW-Metal) was used to reclaim pitting and holes in the deck, then applied in a thicker layer to raise the height of the deck to ensure good drainage in future.
4. 3 weeks after completion the area is draining as intended and the risk of further corrosion has been greatly reduced.
