# BELZONA PROTECTION OF CO<sub>2</sub> COMPRESSOR

ID: 1029

100,000 m<sup>3</sup>/h multistage centrifugal compressor of CO<sub>2</sub>

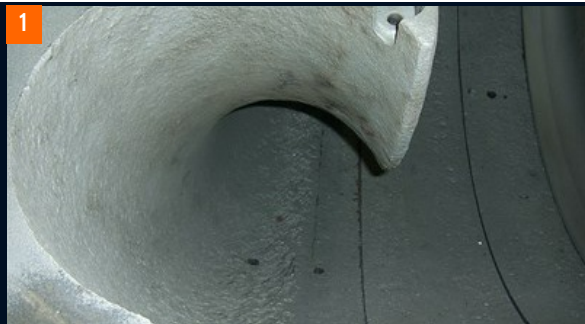
Erosion/corrosion damages on the outlet section due to high temperatures (110°C), water injection and acid contaminated flue gas.

Erosion/corrosion damage to the internal surfaces reviewed after blasting Belzona 1392 applied Belzona 1311 used to fix the stainless steel plates View of the protected internal profile after 2,000 working hours in service of application made in 2005

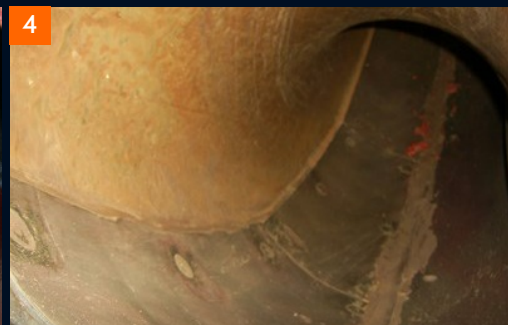
No other effective alternative available. Stainless steel cladding was fit on the most damaged sections using Belzona® 1311 to provide further protection. Inspection after 6 months and 2,000 working hours of the unit reviewed only slight discolouration and loss of gloss. According to this application method five compressors have been protected in the plant.
