# BELZONA ABRASION AND EROSION RESISTANT SYSTEM IN A CIRCULATING WATER PIPE

ID: 10296

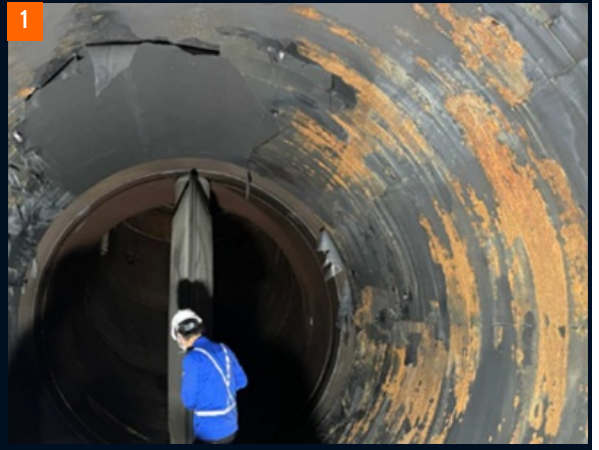
At a power plant in Central Java, Indonesia, rubber lining in circulating water (CW) pipeline spool have failed in early year of operations, due to wrong applications and potentially high flowrates of seawater. After one year of repair on the lining using an elastomeric material, the customer sought a repair for the entire piping system for a long-term protection.

1. Rubber lining damage in a circulating water pipe
2. Application of Belzona 2221 (MP Fluid Elastomer) to restore the lining of the circulating water pipe
3. Rubber lining was removed before the application of a more permanent abrasion and erosion resistant system
4. Complete application of Belzona 1331 in the circulating water pipe

The first phase of the application used Belzona 2221 (MP Fluid Elastomer) to repair damaged rubber linings of the spool.

The rubber lining repair was first carried out using Belzona 2221 (MP Fluid Elastomer) in early 2022.
