# OIL LEAK REPAIR ON A TRANSFORMER USING BELZONA SURFACE-TOLERANT SYSTEM

ID: 10298

## PROBLEM

An energy distributor in New South Wales, Australia reported oil leaking on the transformers in a substation.

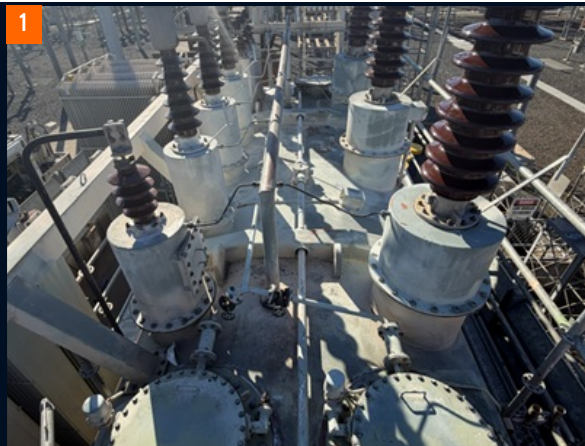
1. The scaffold has been erected around the transformer
2. The transformer was drained and high-pressure hot washed prior to the applicators' arrival.
3. Abrasive blasting carried out on areas requiring repairs
4. Complete application with Belzona 5831 (ST-Barrier) as a protective coating

1. The transformer was drained, scaffolded, and high-pressure hot washed prior to the applicators' arrival.
2. Abrasive blasting was carried out on the main transformer lid, flange, and bolts, as well as the three individual lids, including their flanges and bolts.
3. The prepared areas were prewashed with FP29 Safe Solvent.
4. All bolts (top and bottom) were sealed using Belzona 1161 (Super UW-Metal).
5. After an overnight cure, the Belzona 1161 (Super UW-Metal) was whip/frost blasted.
6. The following day, the main flange was sealed using Belzona 1161 (Super UW-Metal) reinforced with Belzona 9341 Reinforcement Sheet.
7. Belzona 5831 (ST-Barrier) was then applied as a coating to complete the protective system.
8. The repair system was left to cure for 48 hours before the transformer was returned to service.
