# DRAINAGE PIT RESTORATION

ID: 10299

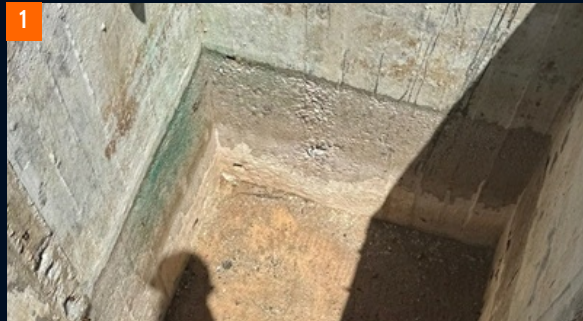
The customer was experiencing deterioration of a concrete drainage pit caused by continuous exposure to water, cleaning chemicals and general service conditions. The degraded concrete surface had become vulnerable to further damage, increasing the risk of chemical ingress, accelerated deterioration and higher maintenance costs. The customer required a durable, chemically resistant solution that could be applied during a planned shutdown, restoring the integrity of the concrete while providing long-term protection and minimizing future maintenance requirement

1. original condition of pit
2. During surface preparation
3. Storage of materials
4. Final finish

The drainage pit was initially cleaned using a high-pressure water jet to remove dirt, contaminants and loose material. The concrete surface was then mechanically abraded using a grinder to achieve a clean, sound substrate suitable for coating application. After surface preparation, Belzona 4911 (Magma TX Conditioner) was applied by brush as the primer. Once the primer had cured to the appropriate stage, Belzona 4311 (Magma CR1) was applied by brush and roller to the specified thickness, ensuring complete and seamless coverage of all concrete surfaces.
