# BELZONA IN-SITU REBUILD OF DECK WINCH

ID: 103

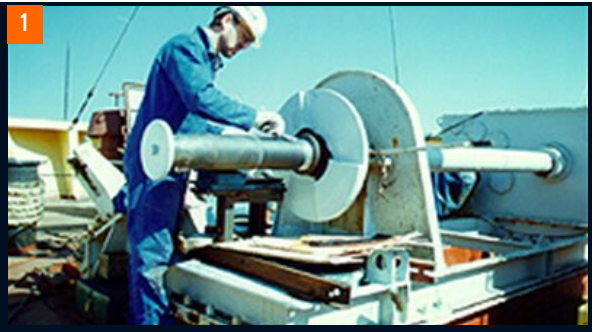
1. Belzona 1131 being applied to the prepared shaft
2. In-situ machining of the Belzona 1131 being carried out
3. The completed application

Application was carried out in accordance with Belzona System Leaflet MPT-1. Portable lathe was used to machine shaft in place without removing or complete dismantling.
