# BELZONA CORRECTS HATCH SEALS

ID: 1030

New rubber seals for cargo ships hatch covers.

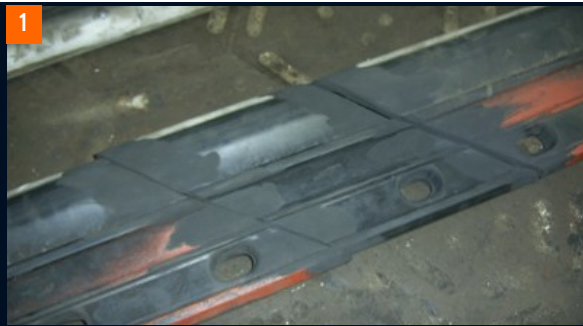
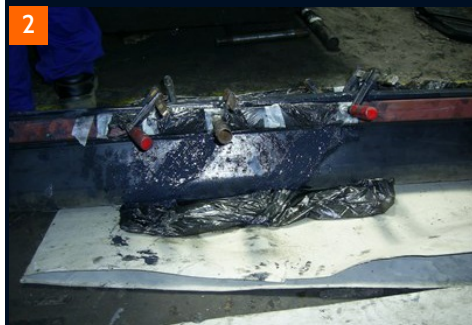
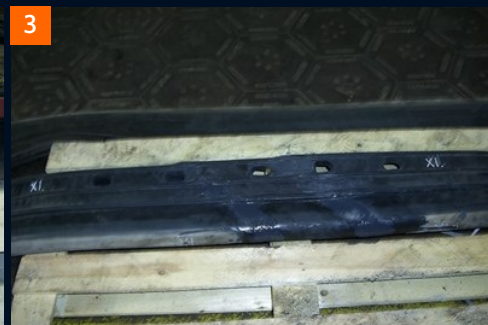
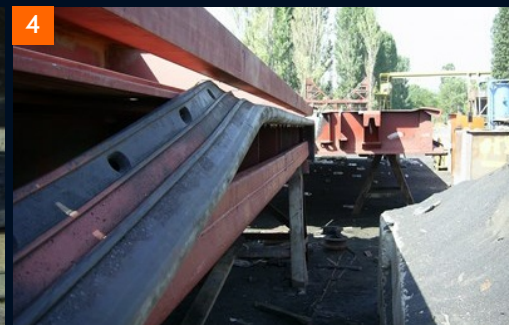
Five new sets of seals supplied were short in length and therefore did not fit the hatches correctly.

1. The three pieces altogether to give the correct length for each seal
2. Application of Belzona 2211 on the joints kept together with metal templates and clamps
3. The assembly after application
4. Mounting of the repaired seal to the cargo hatches

Application was carried out in accordance with a modified version of Belzona Know-How System Leaflet SHM-3. Each rubber seal was cut at angle of 45 degree and between two parts the additional piece to correct the length was inserted. For better joint strength additional rubber strips were cut and bonded inside of the hatch seal pieces. All pieces were assembled and kept together by help of metal templates and clamps until complete cure of the applied Belzona® 2211.
