# STOPPING DAMAGE AND CUTTING HEAT: BELZONA'S DUAL APPROACH TO REACTOR REPAIR

ID: 10300

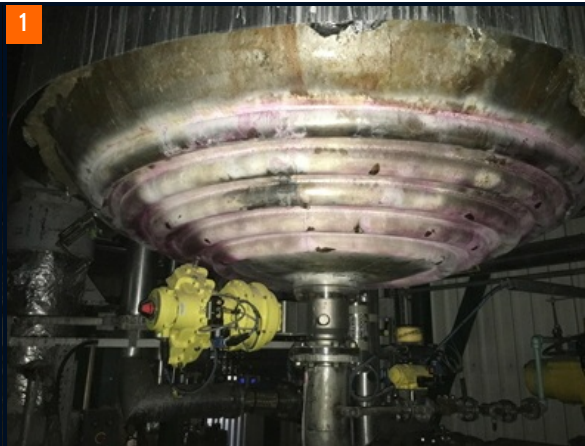
Corrosion around the heating elements of 316L stainless steel acrylic reactors caused through-wall defects and live leaks. A local sales engineer from Belzona UK Ltd has visited the site and demonstrated leak sealing for through-wall defects using Belzona 1511. This repair has been successful and is performing well. However, new weak areas within the reactor have now penetrated the steel, leading to additional live leaks.

1. Stainless steel acrylic reactors showing signs of corrosion and through-wall defects
2. Belzona SuperWrapII system applied to reactor
3. Belzona 5871 is spray applied on top of Belzona SuperWrapII system
4. Completed application has solved corrosion issues, offered long- term protection and reduced risks of contact burns

Once leaking areas were identified and marked, the surface was grit blasted to achieve the required substrate cleanliness standard SA 2½ and a minimum profile of 75µm.

All substrate defects within the area are repaired using Belzona 1511 (Super HT-Metal), including surface reprofiling and filleting where necessary.
