# BELZONA PROTECTION OF 180 STAY VANES AND NEARLY 200 M<sup>2</sup> BOTTOM WATER GUIDE AGAINST EROSION-CORROSION

ID: 10303

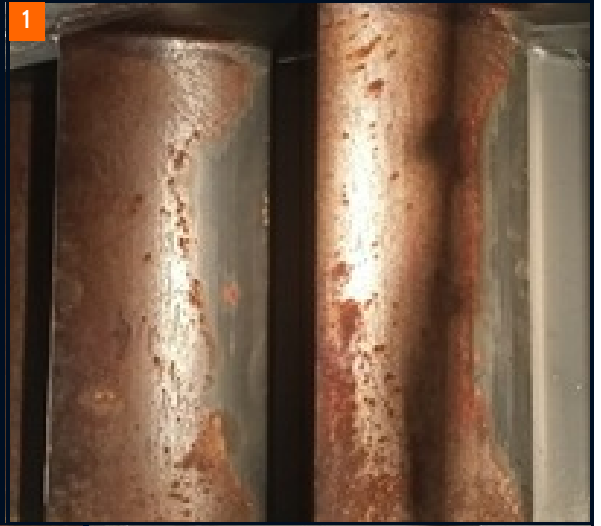
At a hydroelectric power plant in India with a generating capacity of 400 MW, the stay vanes and bottom water guide area of the hydro-turbine were suffering severe erosion-corrosion damage. The customer had previously relied on an epoxy coating system, but it delivered under-rated performance, poor adhesion, and inadequate erosion-corrosion resistance. The earlier coating also had to be reapplied during every shutdown for the last 4–5 years, so it did not deliver the expected service life or long-term protection.

1. Hydro-turbine were suffering severe erosion-corrosion damage
2. Surface was grit blasted to achieve the required surface roughness & cleanliness
3. Application of Belzona protective system
4. Closer view on the hydro-turbine after the application of Belzona solution for erosion-corrosion resistance
