# VACUUM STEAM PIPEWORK REPAIRS WITH BELZONA SUPERWRAP II

ID: 10306

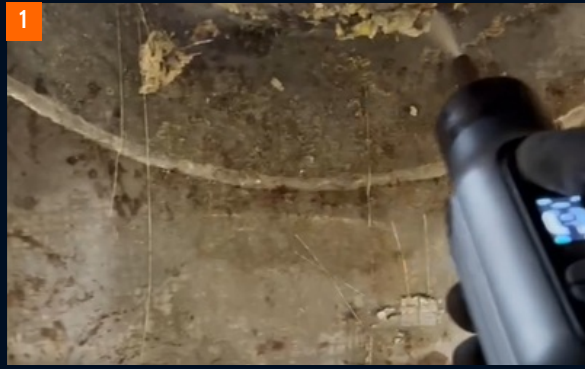
Through wall defects had appeared in the low pressure steam system. These defects were around flanges & tee pieces. The geometry meant traditional repair methods would be very challenging. The thin wall of the pipe ducting meant welding was out of the question. This system runs at partial vacuum pressures so the leaks were sucking in air & causing the pressure to rise - this was affected production. A system was required to seal these leaks in a 24 hour shutdown period.

1. Close up of leaking areas
2. Leaks around flange
3. Completed repairs

The defective areas were first prepared to SSPC-SP11 using an MBX Bristle Blaster. Belzona 1511 HT Metal was used to fair any defects. Belzona 1983 Superwrap II was then applied as a patch system to reinforce the defects.
