# BELZONA 1813 AS A RELIABLE SOLUTION FOR A VERTICAL COAL MILL DISCHARGE PIPE OPERATING AT 200°C AT A THERMAL POWER PLANT

ID: 10311

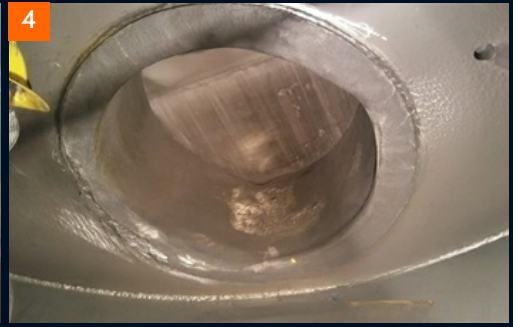
At a coal-based thermal power plant, a vertical coal mill discharge pipe was punctured due to severe coal particle erosion in an interval of 6 months. The pipe was replaced in annual shutdown every year. There was no other solution than to do the patch work from the mill outside or arresting small pulverised coal leaks using sodium silicate. Prior to Belzona application, the customer has also tried competitor's product which failed after one month of application.

1. Application of Belzona system in a confine space
2. Inner view of mill discharge pipe
3. Application of Belzona 1813 in a coal mill discharge pipe
4. Damage prior to application, condition after 1 year

The application was done inside the discharge pipe, a very confined space. The scaffolding was installed to facilitate the application. Belzona 1813 was recommended for its excellent resistance to coal particle. The application took around 24-32 hours to complete, together with surface preparation stage. Inspection after one year confirmed most areas remained intact, with a few sections showed reduced thickness or exposed base metal. These areas were subsequently restored through patch repair.
