# BELZONA REPAIRS AND REINFORCES LEAKS IN GAS THREADED PIPES

ID: 10314

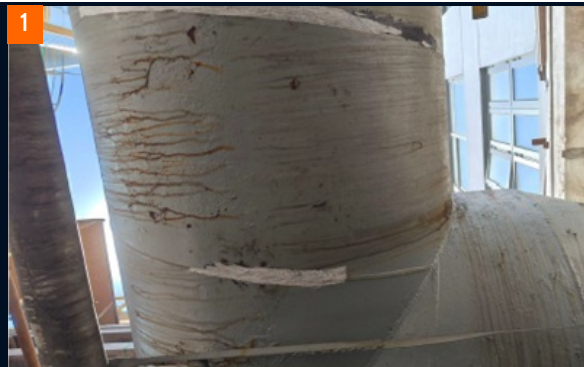
There are sand holes at the base of the threaded pipe at the inlet to the drum cooler, resulting in a slight gas leak. The circumferential welded seam of the threaded pipe requires reinforcement and protection. The pipe is a negative-pressure pipe with a diameter of 1.4 metres and operates at ambient temperature.

1. Leaking pipe with sand holes
2. Application of Belzona 1212 and Belzona 1111
3. Application of Belzona Superwrap II
4. Application completed
